Residential Exterior Experts

Re-roofing 101

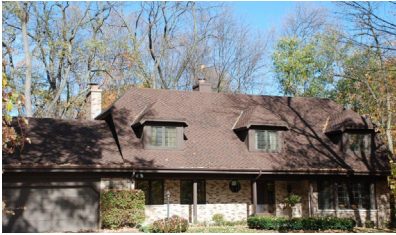
Before:

The roof on this home is over 25 years old. There are two layers of shingles under the top layer. The existing shingles are showing signs of clawing (turning under) and there is some leakage around the flashing.

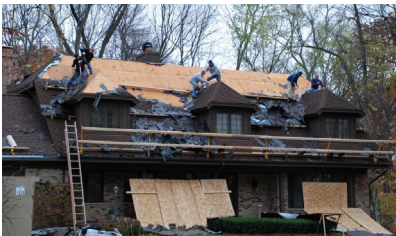
Step 1: Tear-off

The existing shingles are removed and disposed of. Tarps and plywood are used to protect the landscaping around the house.

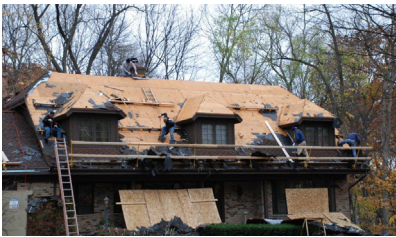
Step 2: Bare Roof

This is our opportunity to inspect the roof deck. We will correct any carpentry issues, add ventilation if necessary, and prepare the building for a new roof.

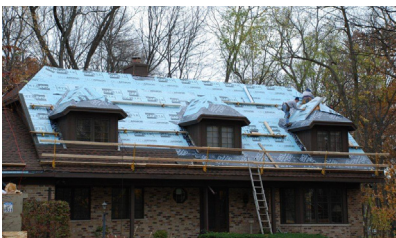
Step 3: Prep Work

The replacement process begins with edging, Ice and Water Shield, GAF Deck Armour and valleys. Chimneys and other projections are prepared for flashing.

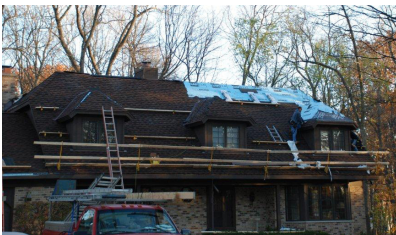
Step 4: Shingling

In this example, our trained professionals carefully installed new GAF HD Barkwood shingles according to the manufacturer's instructions.

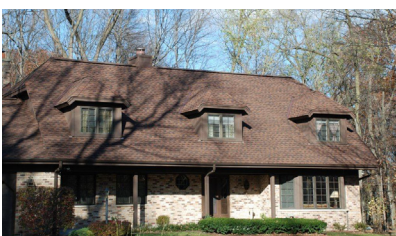
Step 5: Project Completion

The dumpster is removed, the driveway and sidewalks are swept and the job is inspected by a member of the L.H. Krueger and Son staff.
